Transvaginal ultrasound: Beware the cervical cancer

Introduction

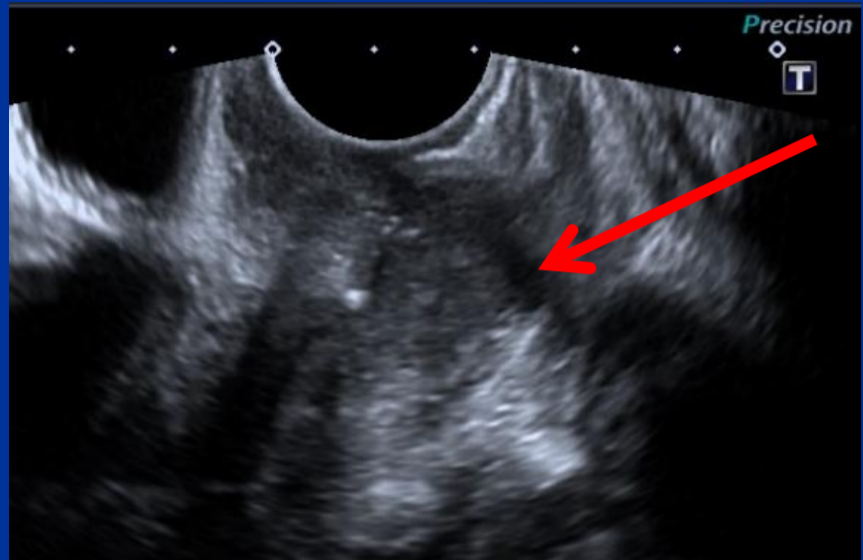
Image 1: Hypoechoic foci within the cervix (red arrow)

59 year old presented with post-menopausal bleeding
Ultrasound demonstrated ill-defined, hypoechoic, vascular areas in the cervix (Images 1 and 2). Fluid was present within the endometrial cavity. On subsequent MRI imaging (Image 3), the hypoechoic foci correlated to a circumferential tumour in the cervix, extending into the upper vagina. Loss of the cervical stromal ring was noted and parametrial spread was present. Tumour also involved the distal left ureter and was inseparable from the sigmoid colon.

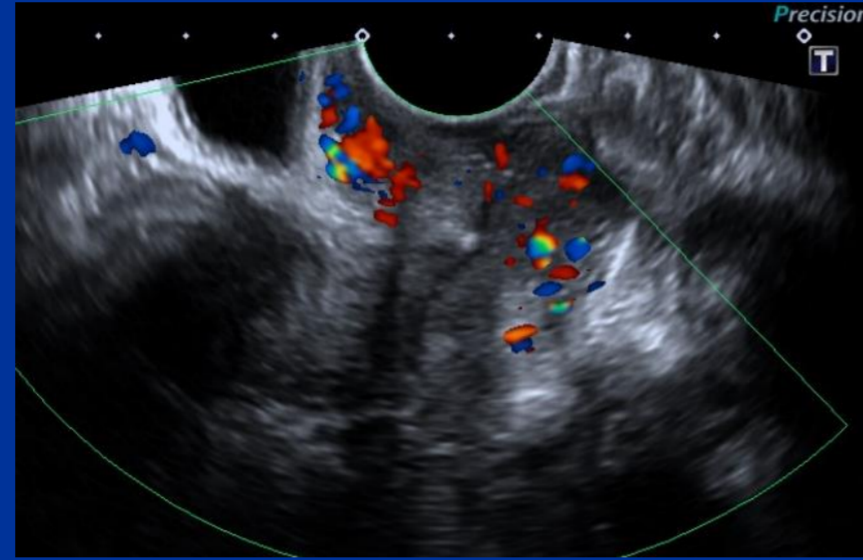
Image 2: Hypoechoic foci in the cervix demonstrates flow on Colour Doppler imaging

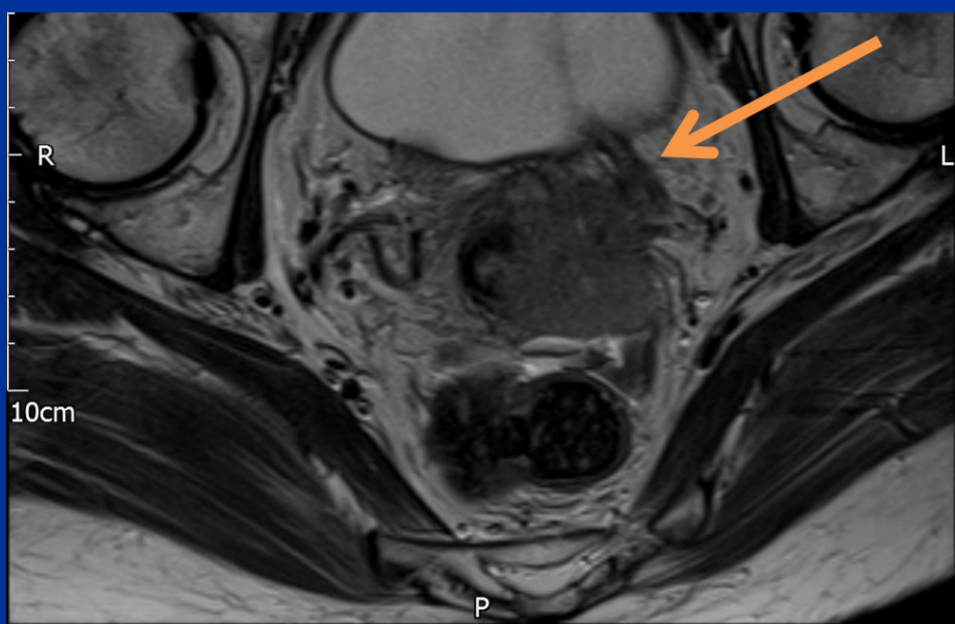
Image 3: The cervical tumour is demonstrated with parametrial spread and involvement of the left distal ureter (orange arrow)

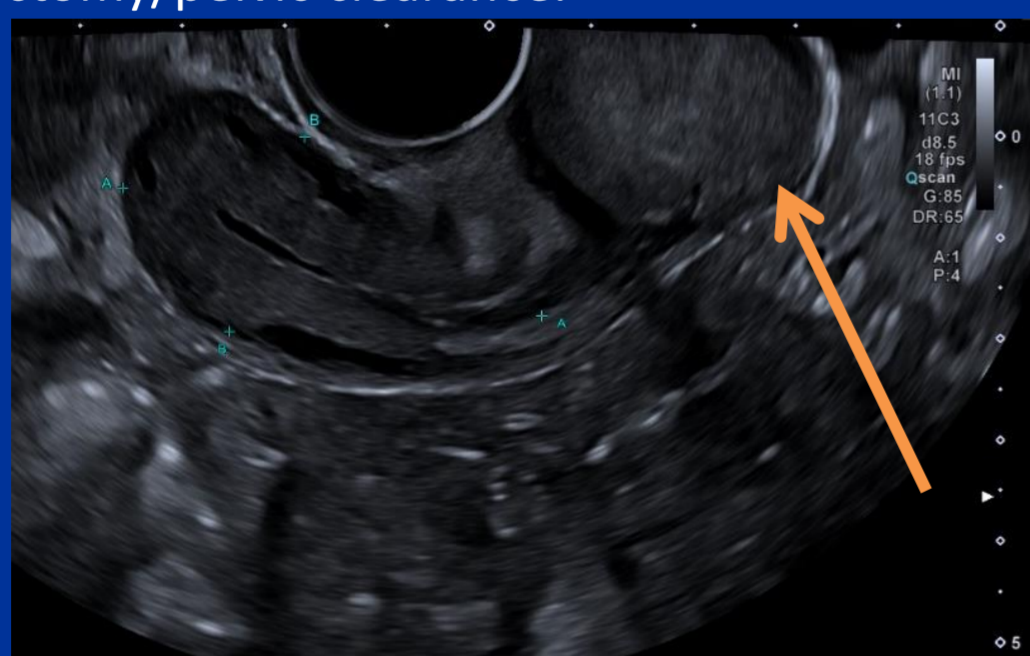
Image 9: Cervical mass seen on longitudinal image of uterus and cervix (orange arrow)

32 year old presented with irregular bleeding and profuse discharge, with a 2cm cervical fibroid on speculum exam.
On ultrasound, the cervical posterior wall contained a heterogeneous, isoechoic, vascular, well-defined lesion measuring 4.1 x 2.8 x 2.4 cm (orange arrow, image 9). A small volume of fluid was present in the endometrial cavity. This was thought to be a cervical fibroid on ultrasound and the patient underwent a local resection of the mass, which was proven to be cervical adenocarcinoma on histology, with involved margins and vascular space invasion. The patient had subsequent pelvic radiotherapy and systemic chemotherapy.
PET-CT and Pelvis MRI 1 month post-surgery did not display any definitive evidence of local disease spread, and there was no evidence of disease recurrence on a repeat Pelvis MRI 5 months postoperatively and no disease was seen on subsequent hysterectomy/pelvic clearance.

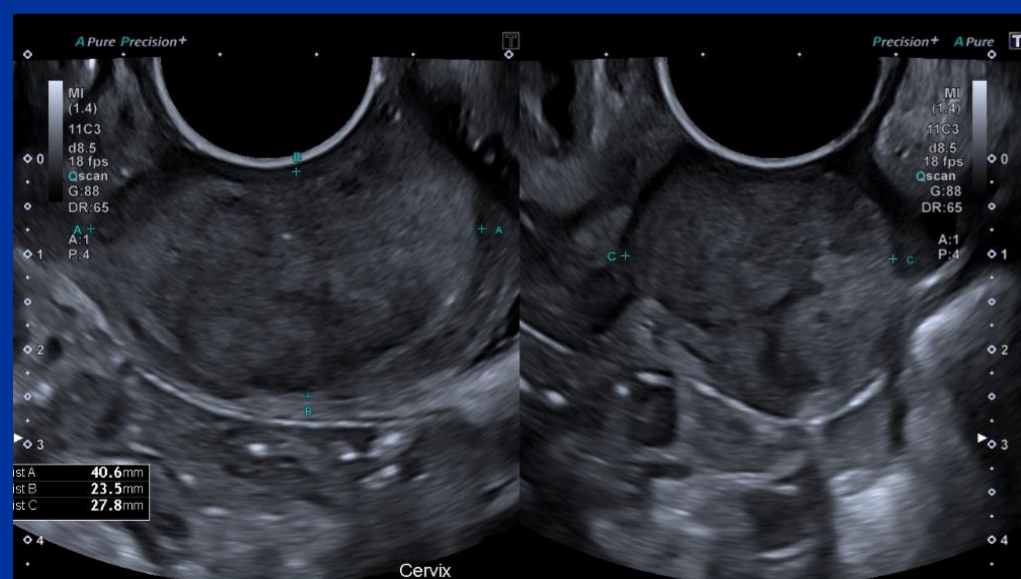
Image 10: Further focused views of the heterogeneous isoechoic cervical mass

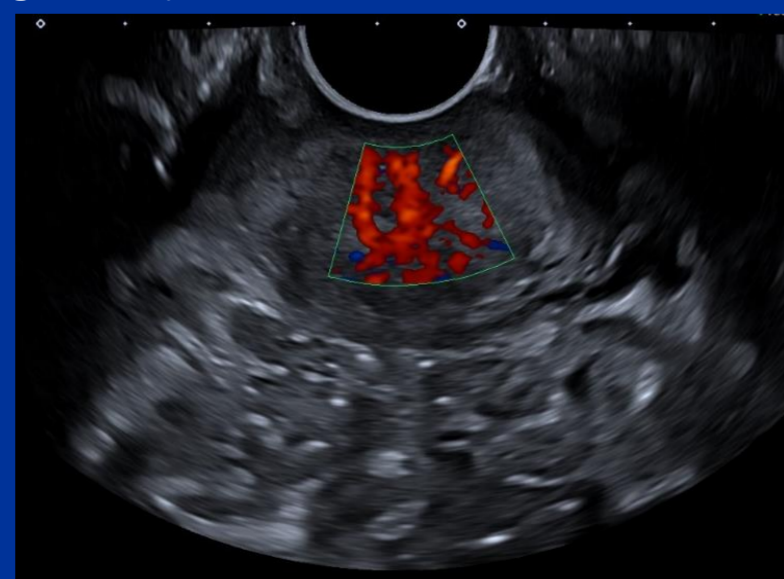
Image 11: The mass demonstrates vascularity on Colour Doppler imaging

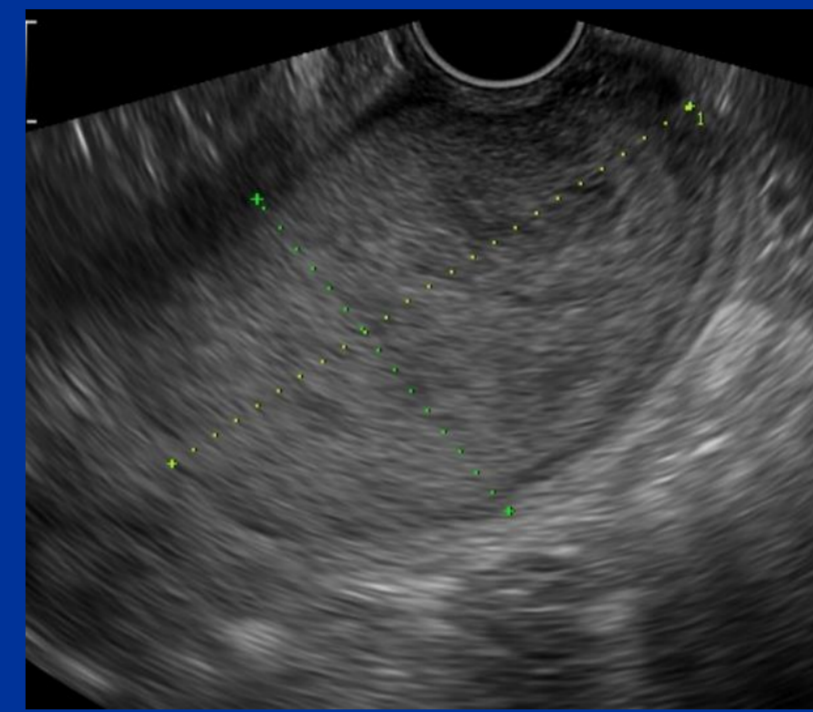
Image 4: Ill-defined heterogeneous lesion in the region of the cervix. The cervix could not be clearly defined.

49 year old presented with heavy PV bleeding for 3 weeks, with lower abdominal pain and anaemia.
Ultrasound demonstrated a rounded lesion in the region of the cervix with regions of flow on colour Doppler imaging (Images 4 and 5). This was thought to either be a mass or degenerating fibroid, biopsy demonstrated a cervical carcinoma.
On MRI, an 8 x 4 x 5cm mass was seen, with intermediate signal on T2 (Image 6) and restricted diffusion (Image 7). The cervical canal was displaced posteriorly. There was loss of the cervical stromal ring on the right (red arrow, Image 8). The lesion had restricted diffusion. Subsequent PET imaging also showed high uptake in this region.

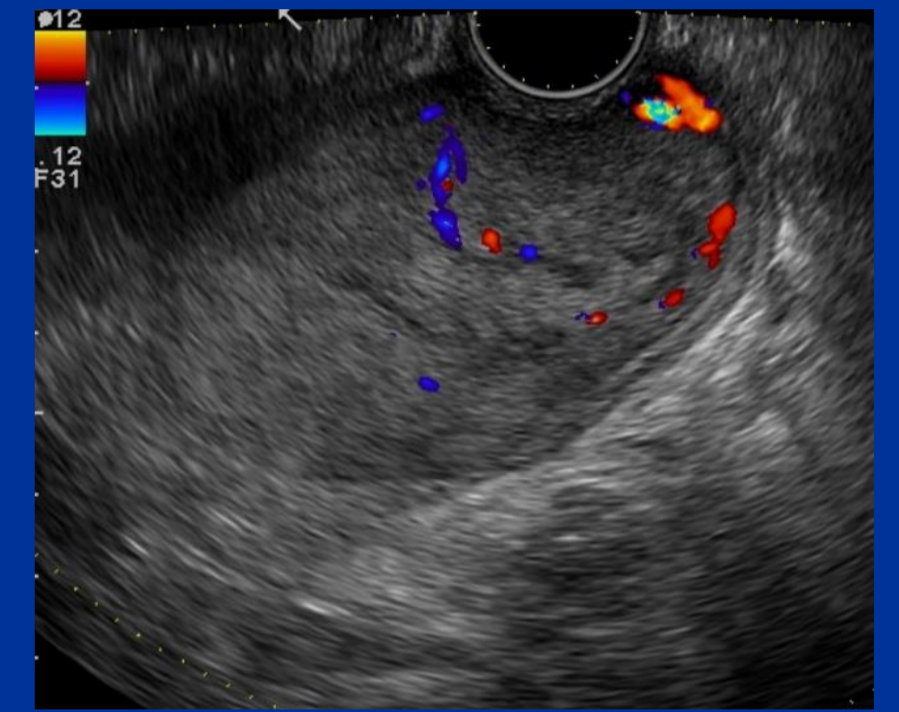
Image 5: The region demonstrated flow on Colour Doppler Imaging.

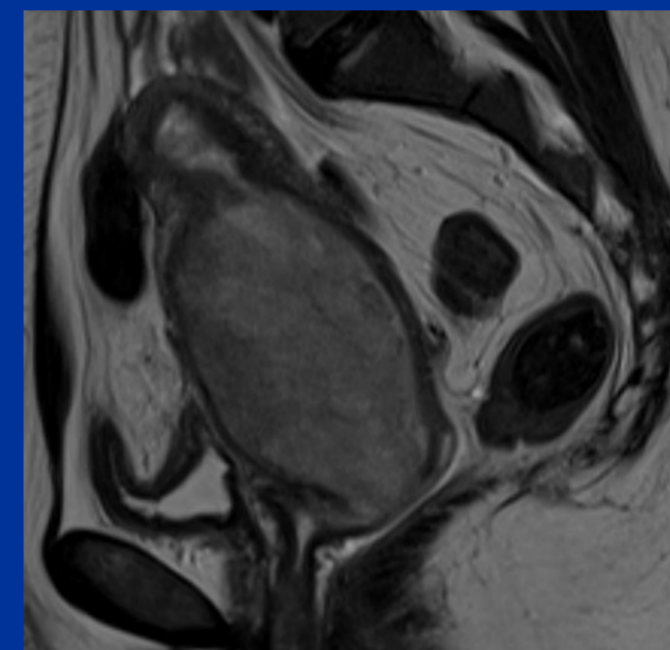
Image 6: 8 x 4 x 5cm mass in the anterior cervix

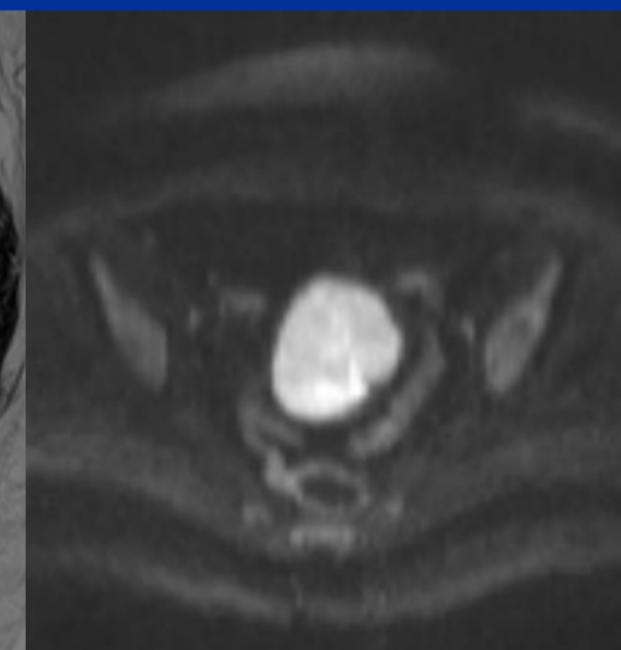
Image 7: The cervical mass has restricted diffusion

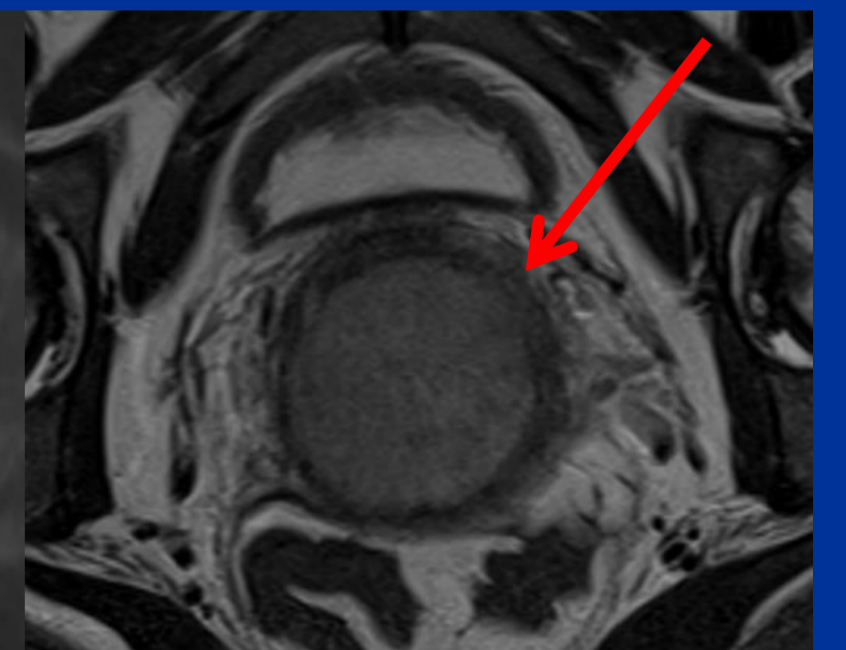
Image 8: Intermediate signal mass with loss of the cervical stromal ring on the right (red arrow)

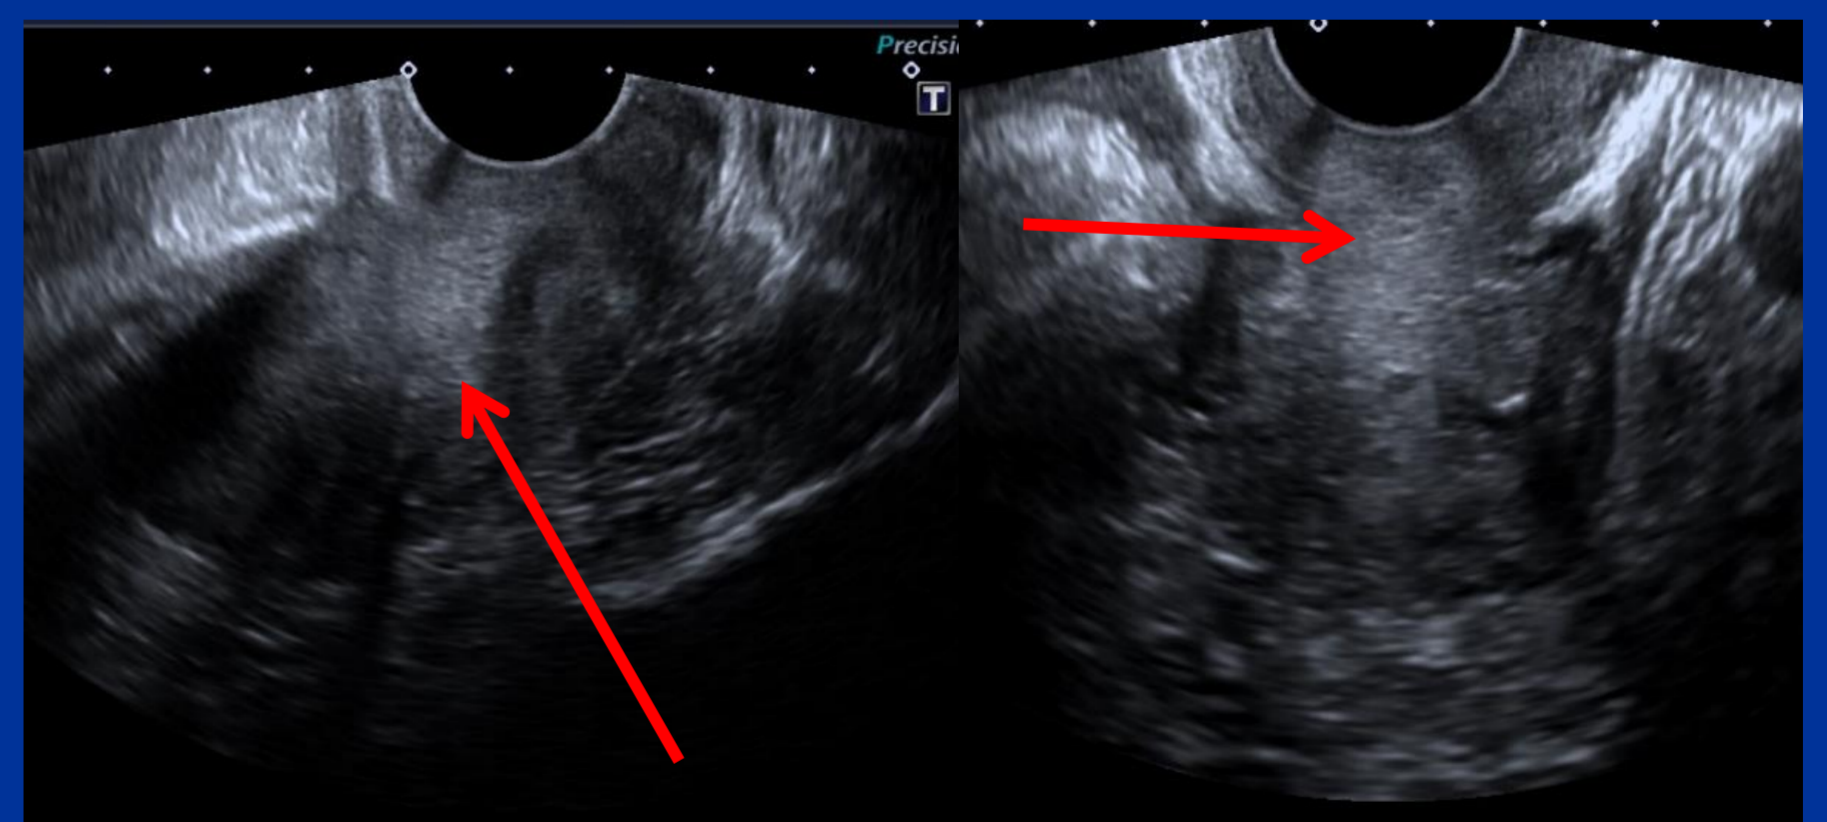
Images 12 and 13: Hyperechoic ill-defined region on longitudinal and transverse images of the cervix and uterus (red arrows)

46 year old presented with menorrhagia. An irregular, echogenic region within the lower anterior myometrium and cervix measuring 1.8 x 3.1 cm was demonstrated on ultrasound (red arrows, image 12 and 13). This region extended from the cervix to the lower uterine segment, from the endometrial canal to the serosal surface. This area was normal in a previous pelvic ultrasound 5 years prior. The patient had a normal hysteroscopy and endometrial biopsy with no cervical mass seen. However the patient also had a pelvic MRI, which did not demonstrate any abnormality in the anterior cervix, but did demonstrate severe adenomyosis, with uterine distortion causing a pseudo-mass appearance.

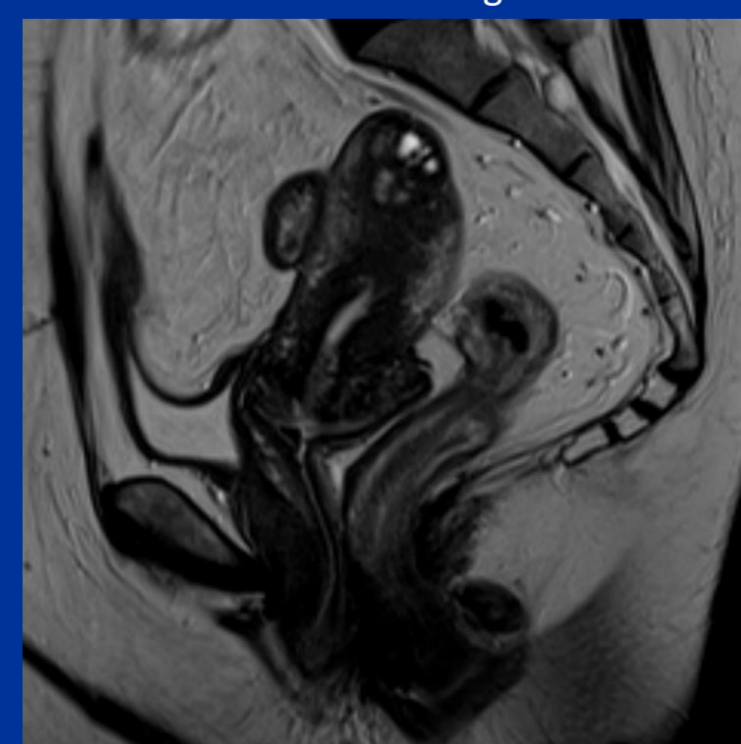
Image 14: Normal appearances of the anterior cervix

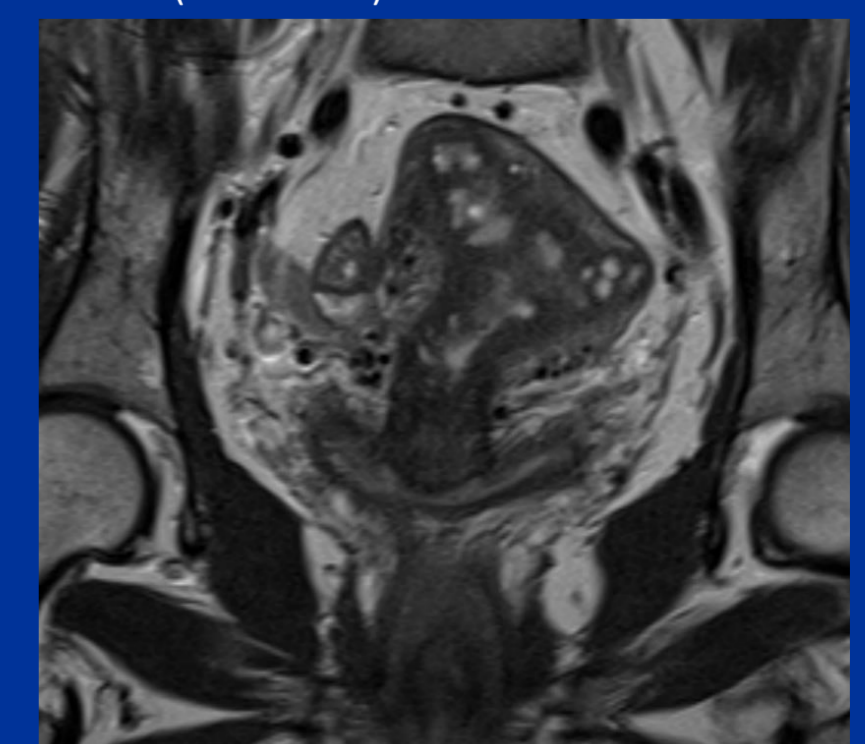
Image 15: Presence of adenomyosis
