## General Medical Image Bank

Testicular Ultrasound March 2021

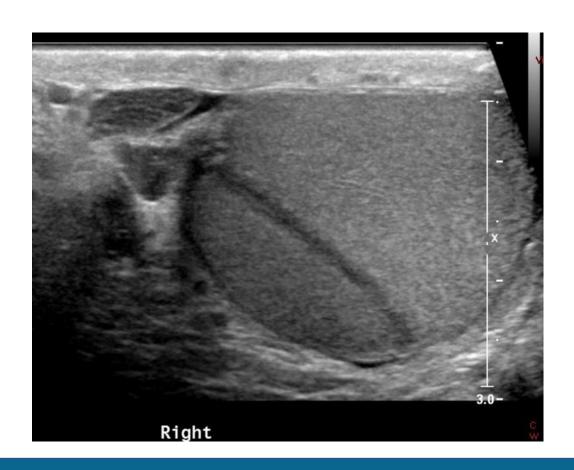
## BMUS\*\*) 1.

What artefact is visible in this normal testis? What may the artfefact be mistaken for?

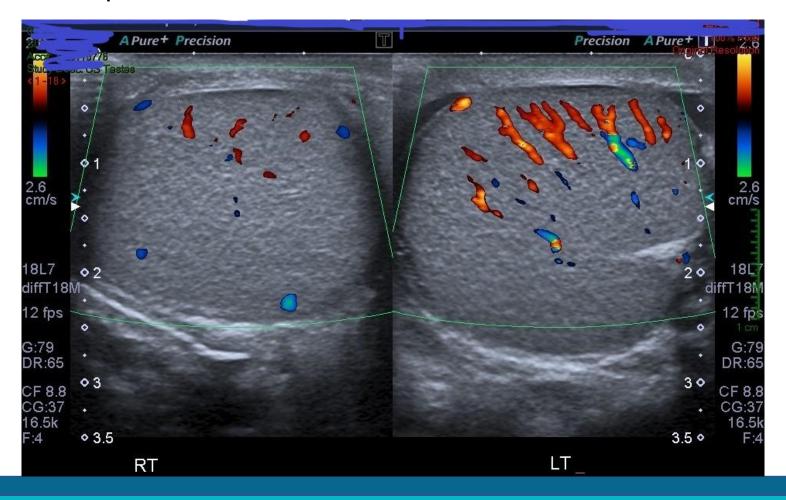
## BMUS\*\*) 2.

What condition is indicated in this 'spectacle image' of a man with left sided pain?

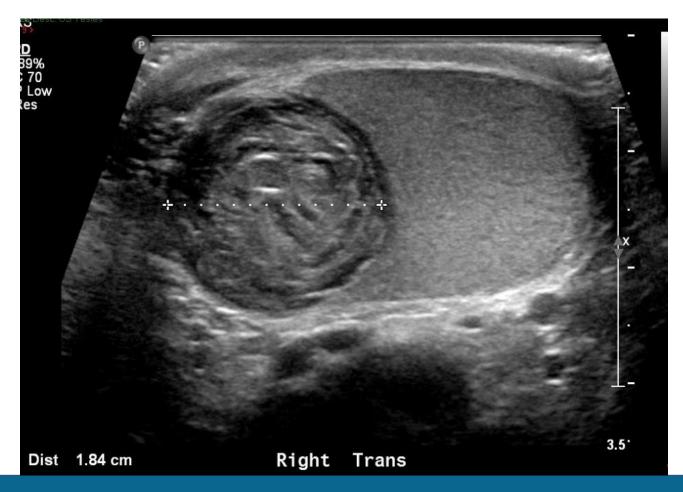
## BMUS\*\*) 3.

The mass in this testis has an 'onion layer' appearance. What type of mass is commonly described as having this pattern?
